**NASHUA RIVER BASIN  
CLINTON, MASSACHUSETTS**

**COACHLACE POND DAM  
MA 00106**

# **PHASE I INSPECTION REPORT NATIONAL DAM INSPECTION PROGRAM**

**OCTOBER 1978**

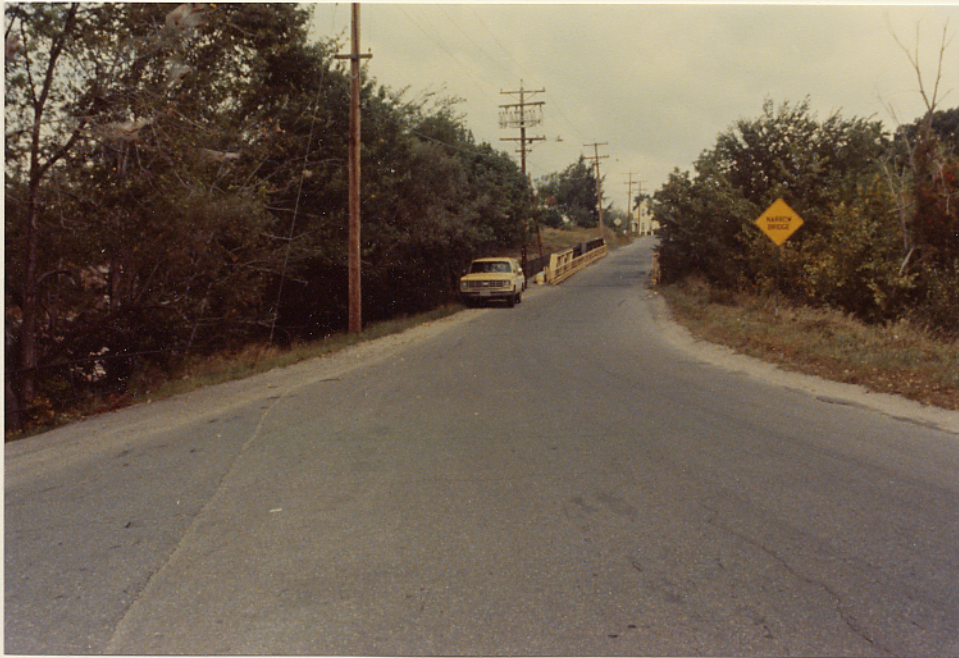
- b. Dam. Coachlace Pond dam is an earthfill dam with two merging roads on the crest and a stone wall along part of the top of the upstream slope. The earth embankment is generally in fair condition. The crest of the dam is mostly covered with asphalt pavement which is in good condition. Along the upstream edge of the crest, there is a wall 1.5 feet high made of cut granite blocks and extends from near the gate house to near the intersection of Old Harbor Road and Franklin Street. The wall does not appear to be a structural element of the dam, and may have been built to support the pipe railing which is on top. The wall is tilted in the upstream direction, and the pipe railing is collapsing in places. The earth slope along the bottom of the wall down to the water surface is covered with loose riprap. This slope is thickly overgrown with brush and trees 6 to 12 inches in diameter. From the southeast end of the stone wall to the southeast abutment, the upstream face of the dam is a sandy slope which is not covered or riprapped. Wave action from the pond and surface runoff from New Harbor Road have eroded this portion of the upstream face of the dam. Localized erosion from surface runoff has also occurred on the upstream slope at a low spot near the midpoint of the dam and at the approach channel to the gate house. The downstream face of the dam is in good condition. No seepage was observed and the slope

**NO. 1 VIEW OF CREST OF DAM FROM SOUTH ABUTMENT**

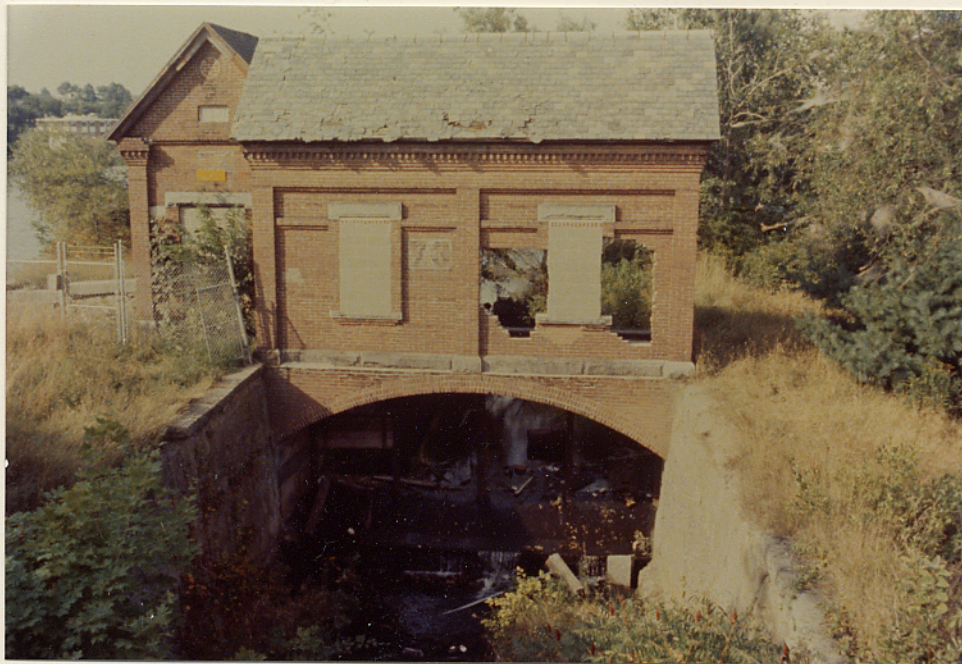
The overall condition of the dam is considered to be fair, although the spillway and outlet structures are in poor condition. The brick in the service house over the spillway has been severely damaged. The building could be a serious hazard if it collapses and blocks the spillway channel. The railroad spur across the downstream channel is an obstruction to flow and produces gaps in the side walls of the downstream channel. Water is seeping from the stone foundation of the spillway along the downstream face and at both side walls. The mortar facing of the side walls is severely eroded, and the capstones are falling into the channel. Several obstructions are located in the floor of the spillway channel, including three manholes and a growth of trees and brush. The trash rack upstream of the spillway is not securely mounted and could also become an obstruction if washed downstream.

**NO. 2 VIEW LOOKING UPSTREAM SHOWING SPILLWAY WITH  
SERVICE HOUSE AND GATE HOUSE ON LEFT**

- a. Operating and Maintenance Procedures. The dam and appurtenant structures are not adequately maintained. It is recommended that the Owner accomplish the following:
  - (1) remove the deteriorating service building over the spillway, including the walkway
  - (2) remove the I-beams from the crest of the spillway
  - (3) grout stonework beneath the crest of the spillway and at the side walls where leakage is occurring and resurface with mortar; also repair the asphalt surface on the crest of spillway
  - (4) resurface the side walls of the spillway channel and approach channel to gate house A

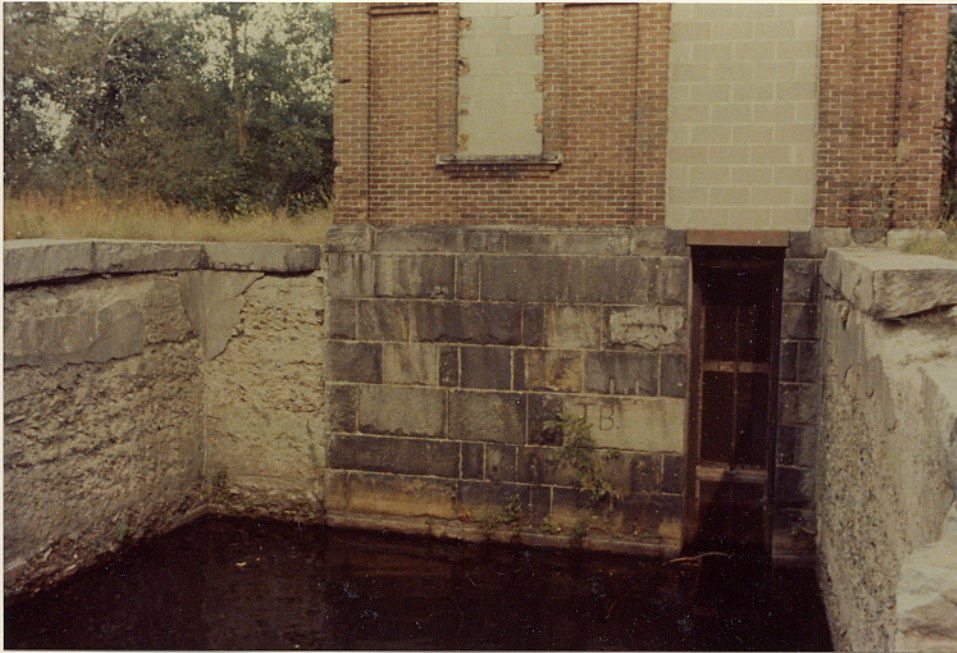
The outlet works at the dam include an upstream and a downstream gate house and two outlet conduits. The upstream gate house is a brick building with an approach channel from the pond. The brick work on the gate house is in good condition, but the roof is starting to collapse. Access to the gate house has been blocked, therefore, an inspection of the gates and outlet conduits could not be made. The mortar facing on the side walls of the approach channel is severely cracked and eroded. The downstream gate house is a small brick building containing 5 gate valves. The only access to the building is through a hole in the wall. There is 1 to 2 feet of standing water in the bottom of the building, and the wood floor has completely collapsed. The gate stems, however, are above water, but do not have any operating mechanism attached.

NO. 3 VIEW OF INLET TO GATE HOUSE

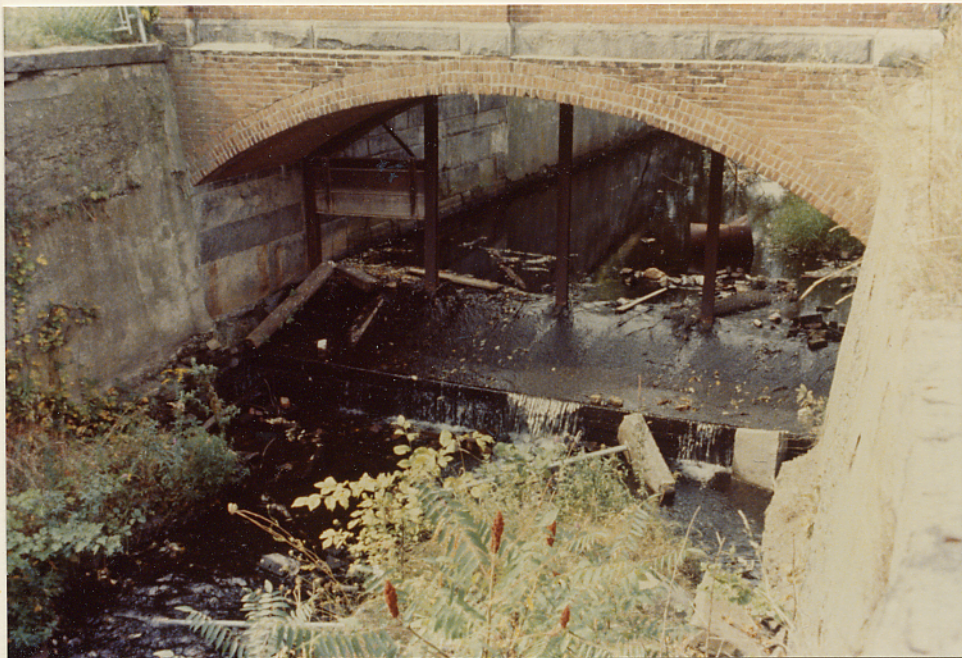
b. Weir and Training Walls *	weir has 4 bays separated by 3 I-beams wooden boards propped open in SE bay
General Condition of <del>concrete</del> Asphalt surface	fair - pulling away from sides
Rust or Staining	not applicable
Spalling	erosion of mortar facing at base of both side walls at DS edge of weir
Any Visible Reinforcing	not applicable
Any Seepage or Efflorescence	seepage from DS face of weir, esp. at both sides + from both side walls
Drain Holes	immediately DS of weir none visible

NO. 4 VIEW OF SPILLWAY

- (5) repair the trash rack upstream of the spillway
- (6) backfill eroded areas on the upstream face of the dam and protect those areas with riprap
- (7) clear trees and brush from the floor of spillway channel and from the upstream face of dam
- (8) annually clean debris from along the chain link fence at the downstream toe of the dam
- (9) institute a definite plan for surveillance and warning system during periods of unusually heavy rains and/or runoff
- (10) implement a systematic program of maintenance inspections. As a minimum, the inspection program should consist of a monthly inspection of the dam and appurtenances, supplemented by additional inspections during and after severe storms. All repairs and maintenance should be undertaken in accordance with all applicable State regulations.
- (11) technical inspections of this dam should be conducted on an annual basis

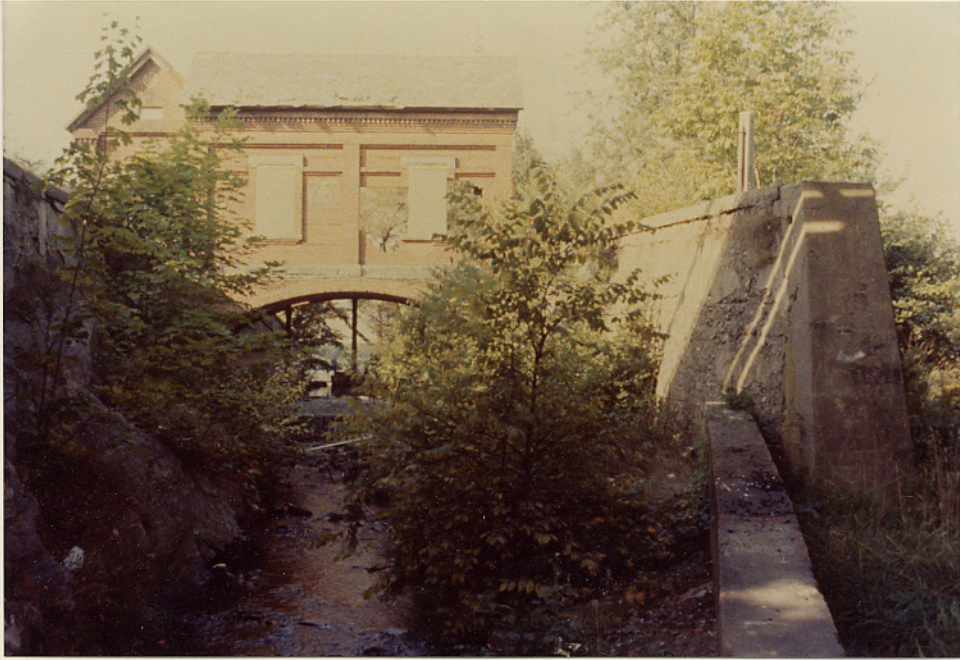
c. Discharge Channel	24' wide channel w/ vertical side walls bedrock in floor + sides
General Condition	poor - walls eroded, capstones falling into channel - debris + brush in floor
Loose Rock Overhanging Channel	loose capstones on side walls
Trees Overhanging Channel	none
Floor of Channel	brush + small trees growing - debris (trash + wood)
Other Obstructions	manhole in floor ± 75' DS of spillway RR spur crosses ± 60' DS of spillway discharge pipes (3), 2 at 20" + 1 at 12" beneath RR spur

**NO. 5 VIEW LOOKING UPSTREAM SHOWING  
CHANNEL BELOW SPILLWAY**

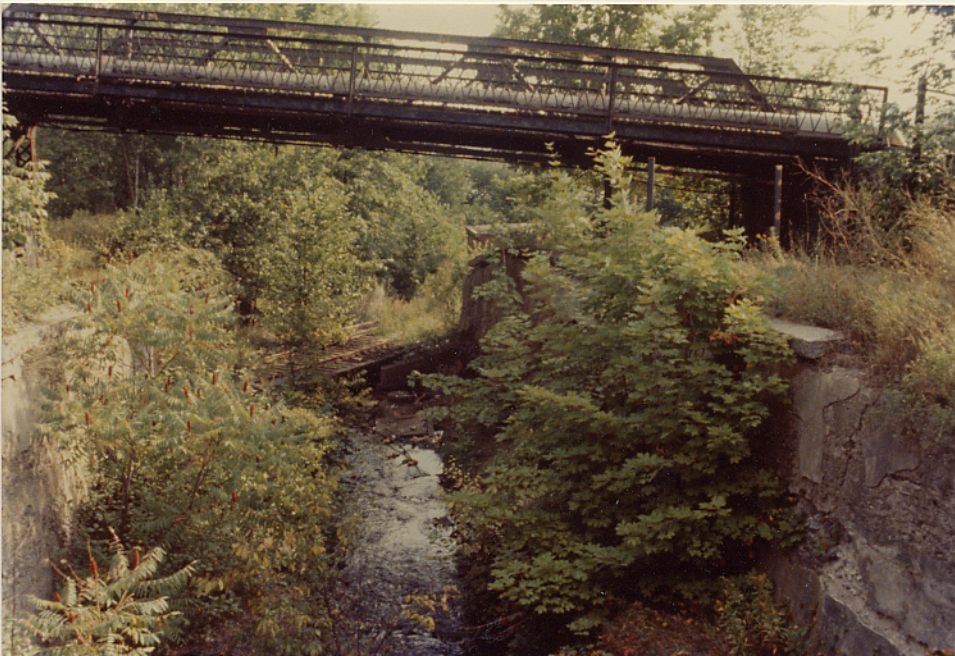
A sewer manhole is located in the middle of the channel about 75 feet downstream of the spillway. Where the railroad spur crosses the channel, there are no side walls to the downstream channel. At this point, water flows through a narrow opening between concrete support walls beneath the railroad spur. Two 20-inch diameter cast-iron drain pipes are also located beneath the track, but these are clogged with debris at the upstream end. The railroad track appears to be in fair condition, but is not used and is an obstruction to flow. The channel below the railroad has a thick growth of trees and brush along the tops of the side walls, and some brush growing in the floor. Wood and other debris is also scattered on the floor.

**NO. 6 VIEW LOOKING DOWNSTREAM SHOWING  
CHANNEL BELOW SPILLWAY**
